# A Novel Approach to TMDL Implementation at a Watershed Level

City of Chattanooga  
Mo Minkara, Ph.D., P.E.  
Water Quality Manager  
[minkara\\_m@mail.chattanooga.gov](mailto:minkara_m@mail.chattanooga.gov)

# Putting the pieces together for pathogen reduction program in urban streams

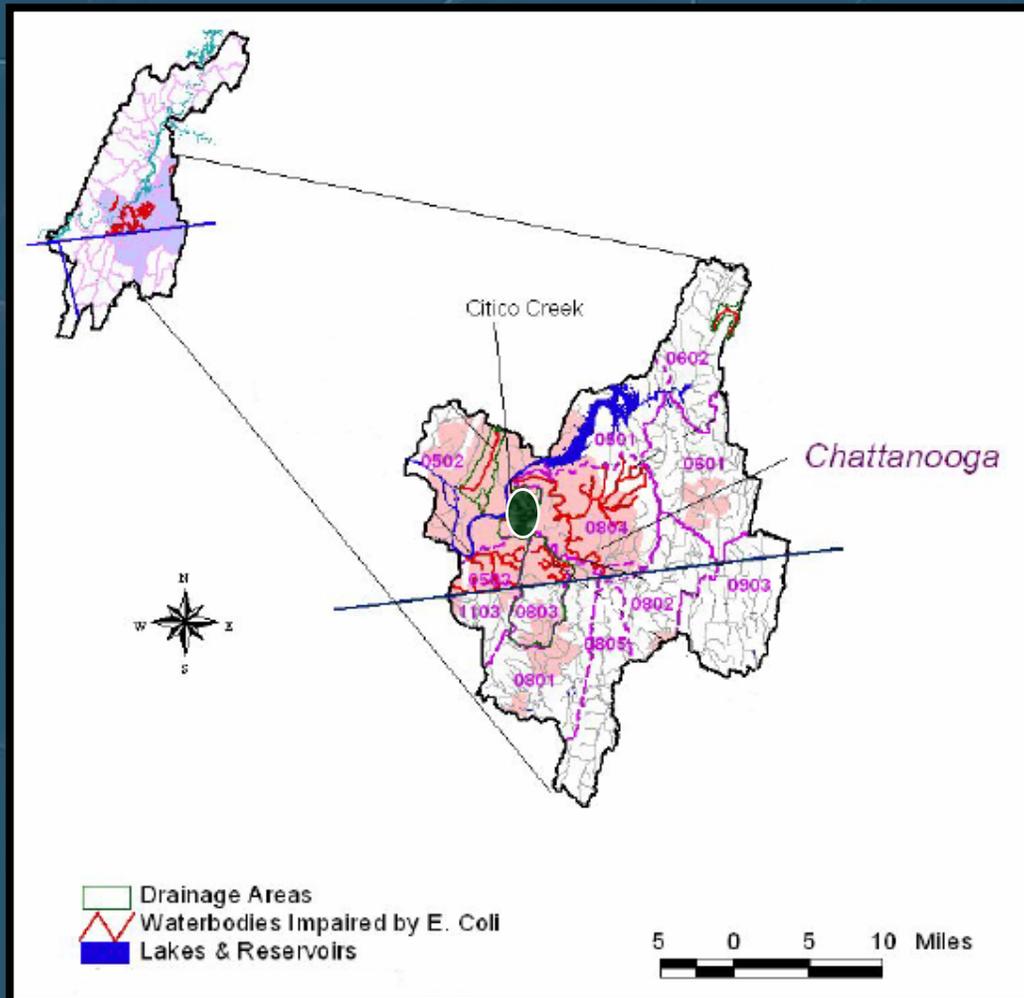
# Where is the Citico Creek Watershed ?

- The Citico Creek Watershed is located within the Lower TN River Watershed
  - **Drains approximately 2,514 Acres**
  - Contains 23 sub-watersheds (or sub-basins)
  - **Approximately 90% of the stream channel is rock & mortar**

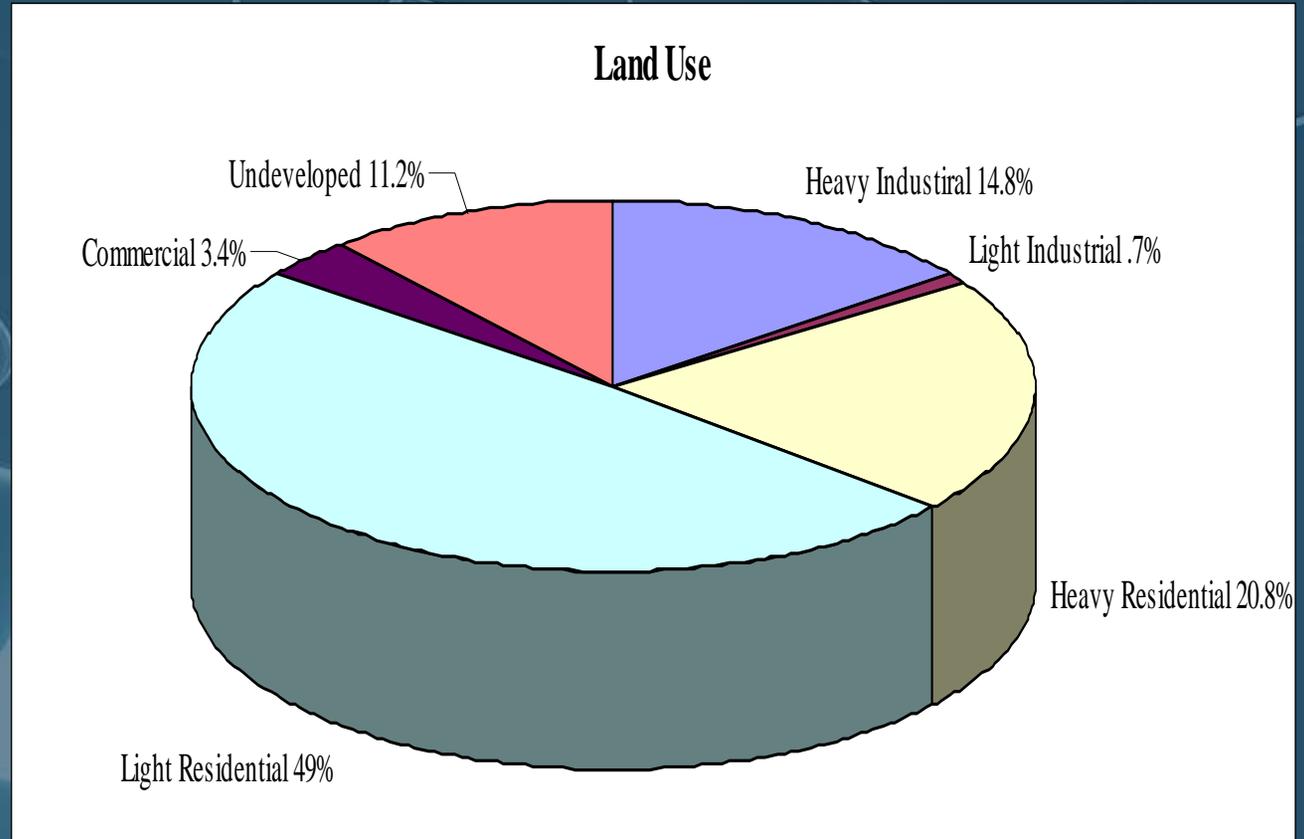
Highly Developed  
Watershed

Impervious Cover

12 % - 45 %

Typical urban watershed

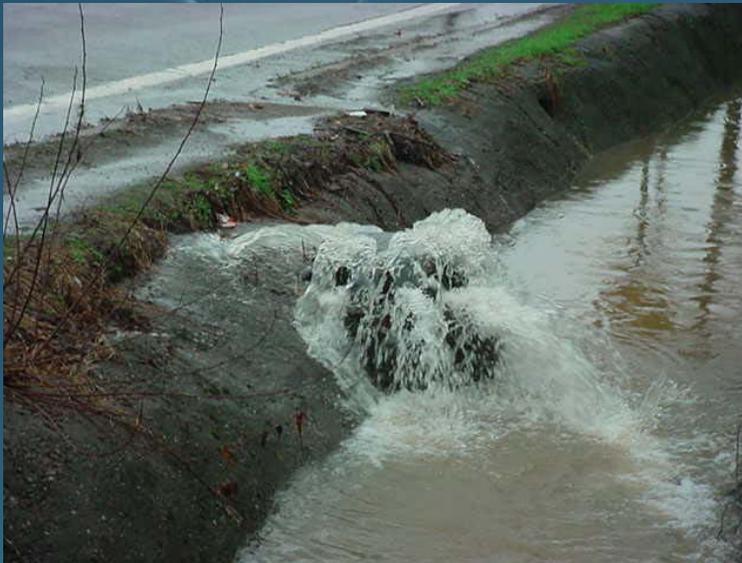
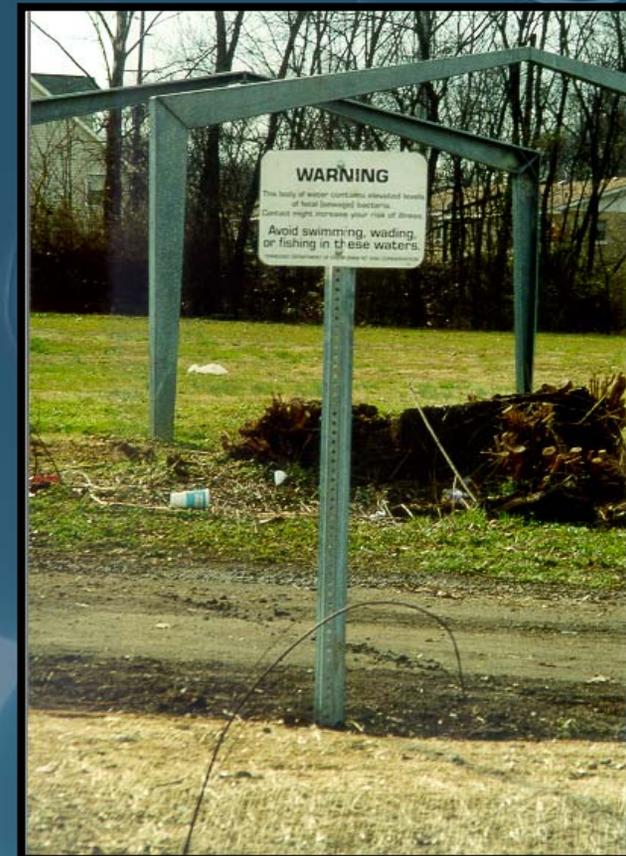
- Poor water quality as demonstrated by that fact that portions of the creek is currently "*Posted Against Human Contact*" due to elevated pathogen levels
- Age of the sanitary infrastructure

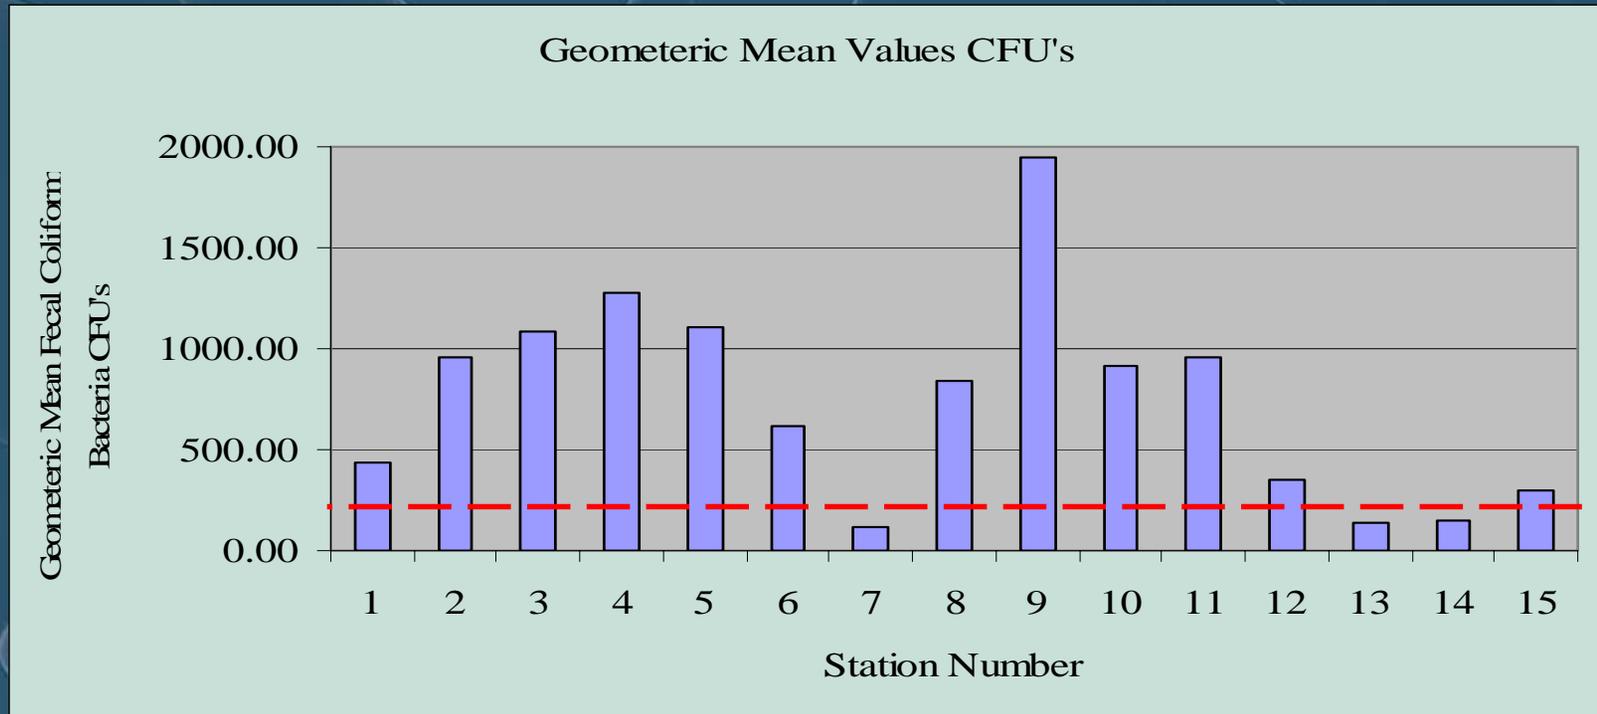
- Historical Water Quality Data
- Portions of Citico Creek have consistently shown pathogen levels in excess of state water quality standards.
- Listed in the 303(d) list for pathogens impairment

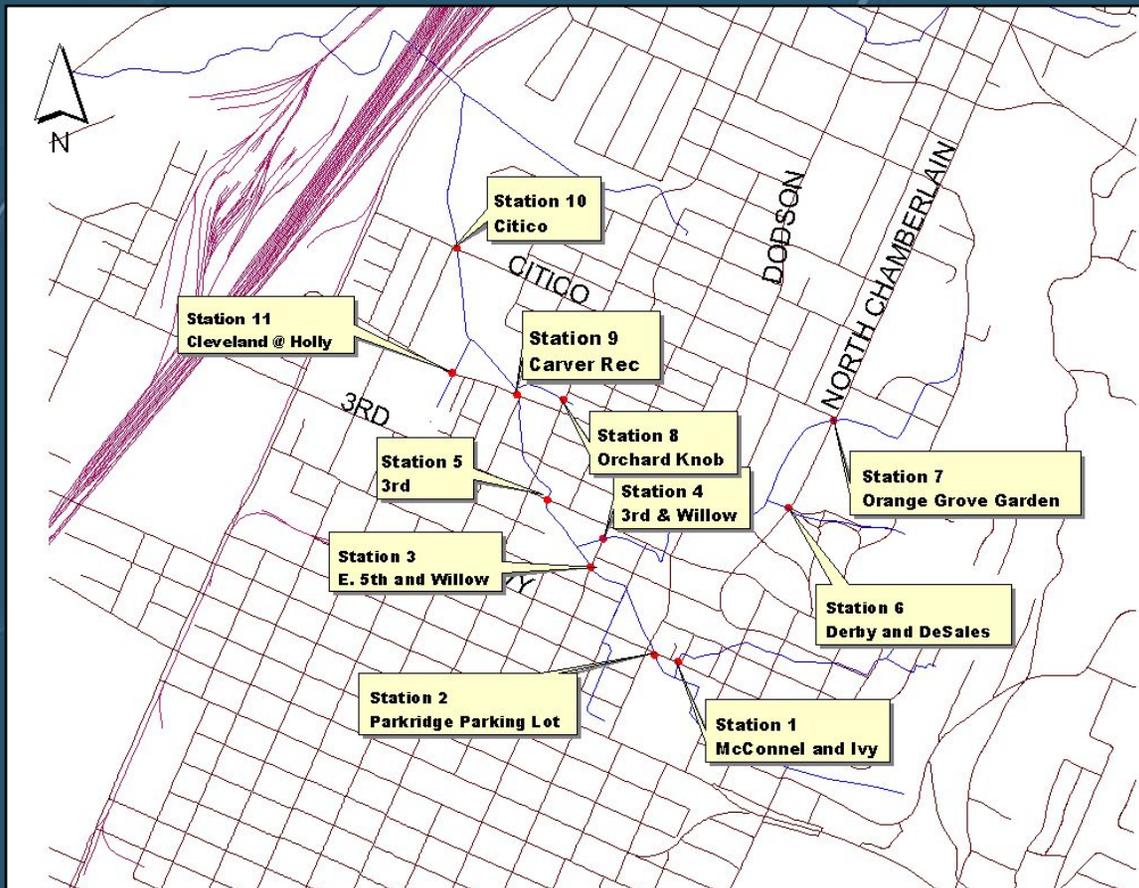
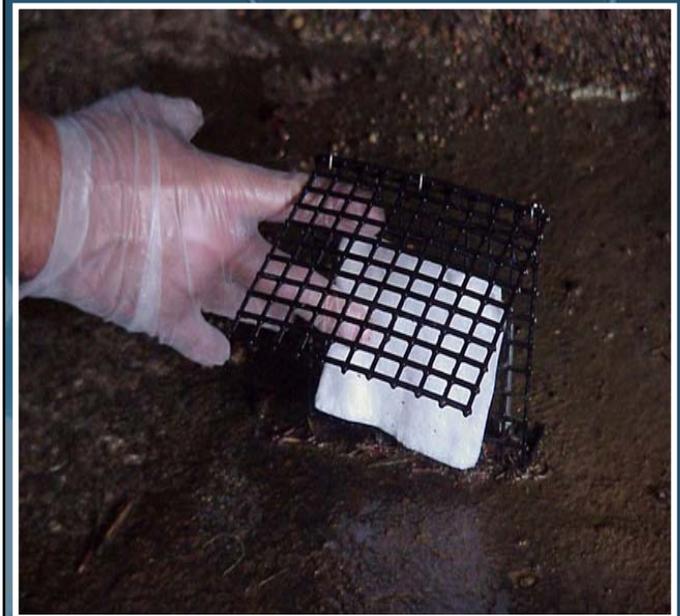
# Source Identification

Optical brightener analysis indicated that pathogen sources came from anthropogenic activity.

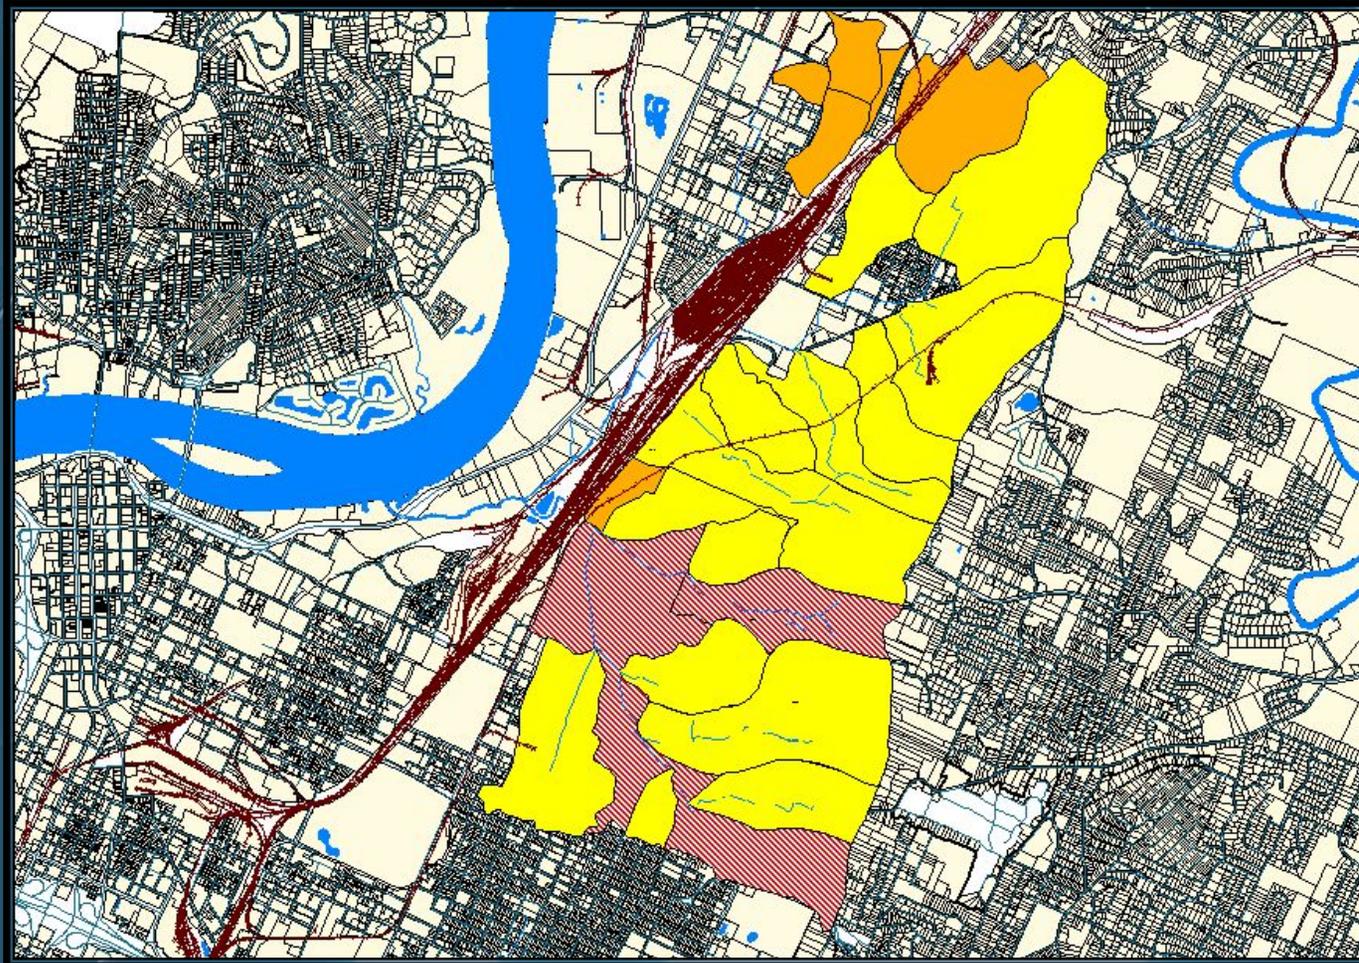
Preliminary watershed characterization

IDP (Illicit Discharge Potential) Score

Results showed that the target basins were the ones currently posted.

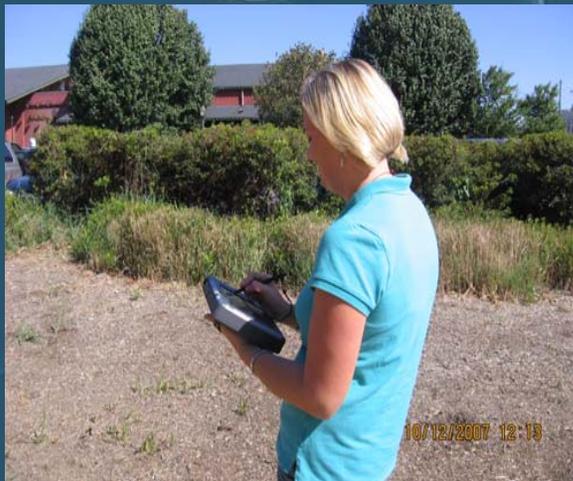
Anomalies were “marked” in the field and documented in a geodatabase.

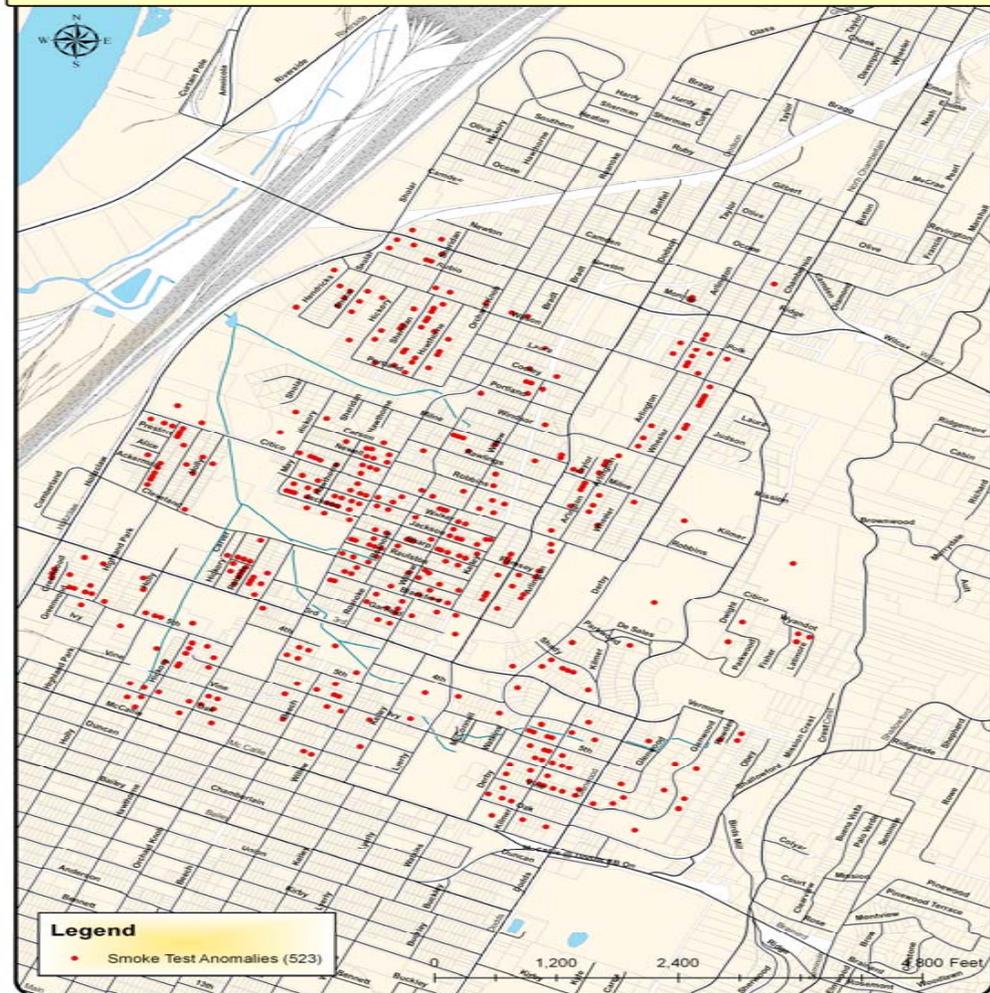
## SEP Smoke Test Area (Anomalies)

- Property owners were sent notification letters requesting repairs be made to their private sanitary sewer lateral.
- Applications were provided to eligible homeowners and reviewed by a reviewing committee.
- Work orders were created for City sanitary sewer lines repair.

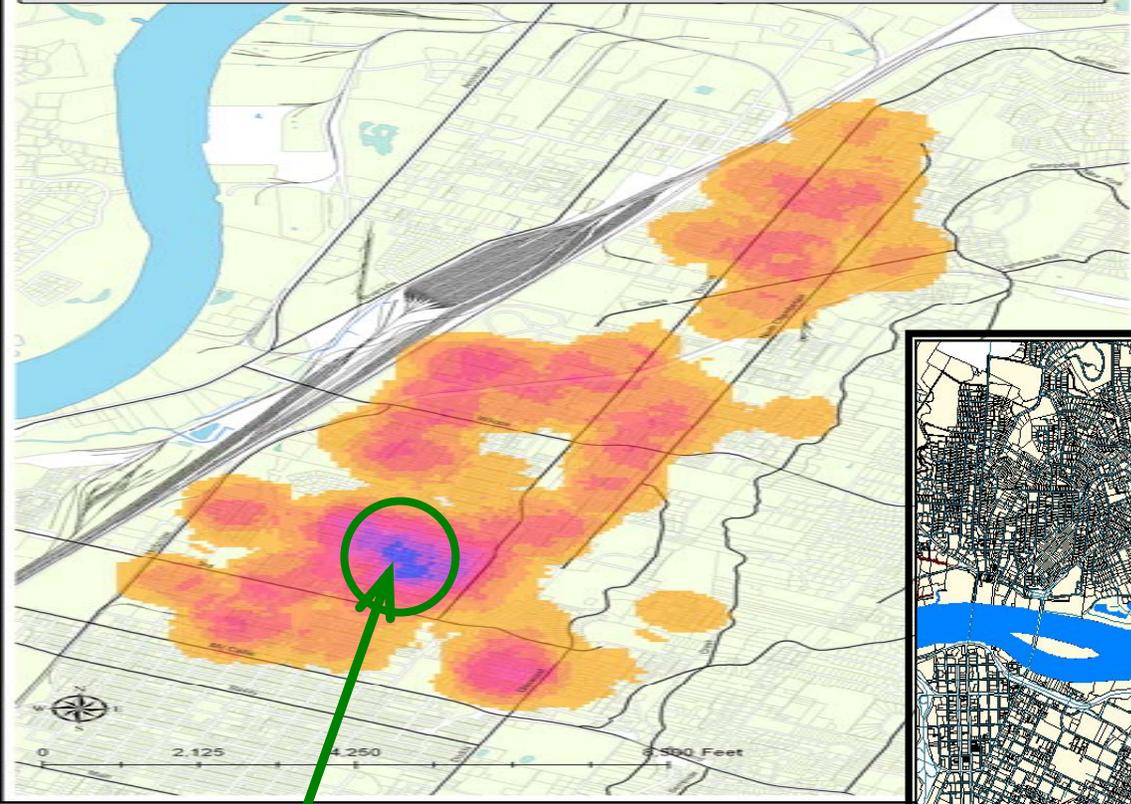
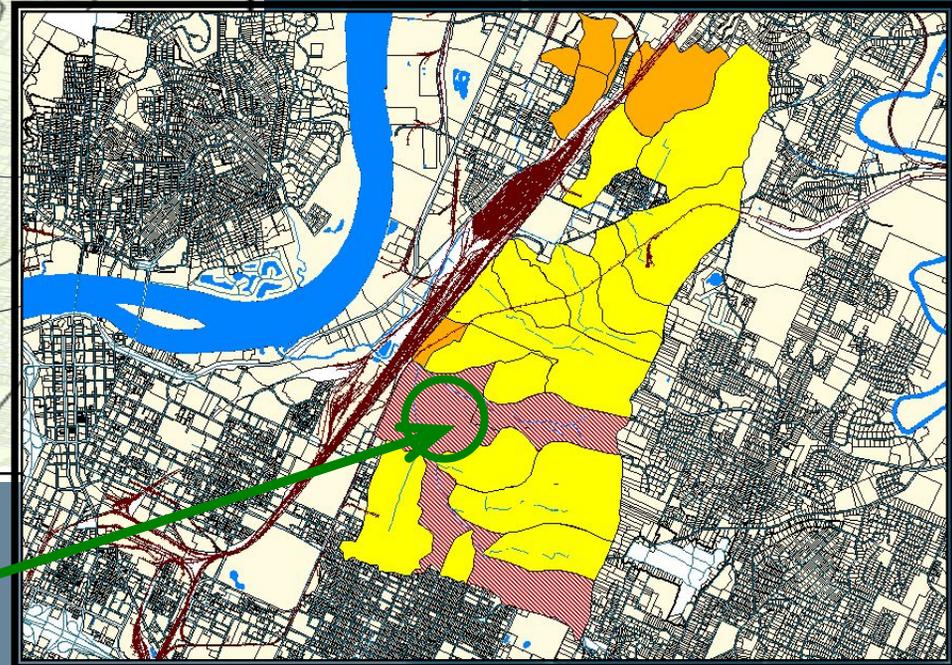
Citico Smoke Test Density Analysis

Spatial analysis of anomaly density verified the IDP score.

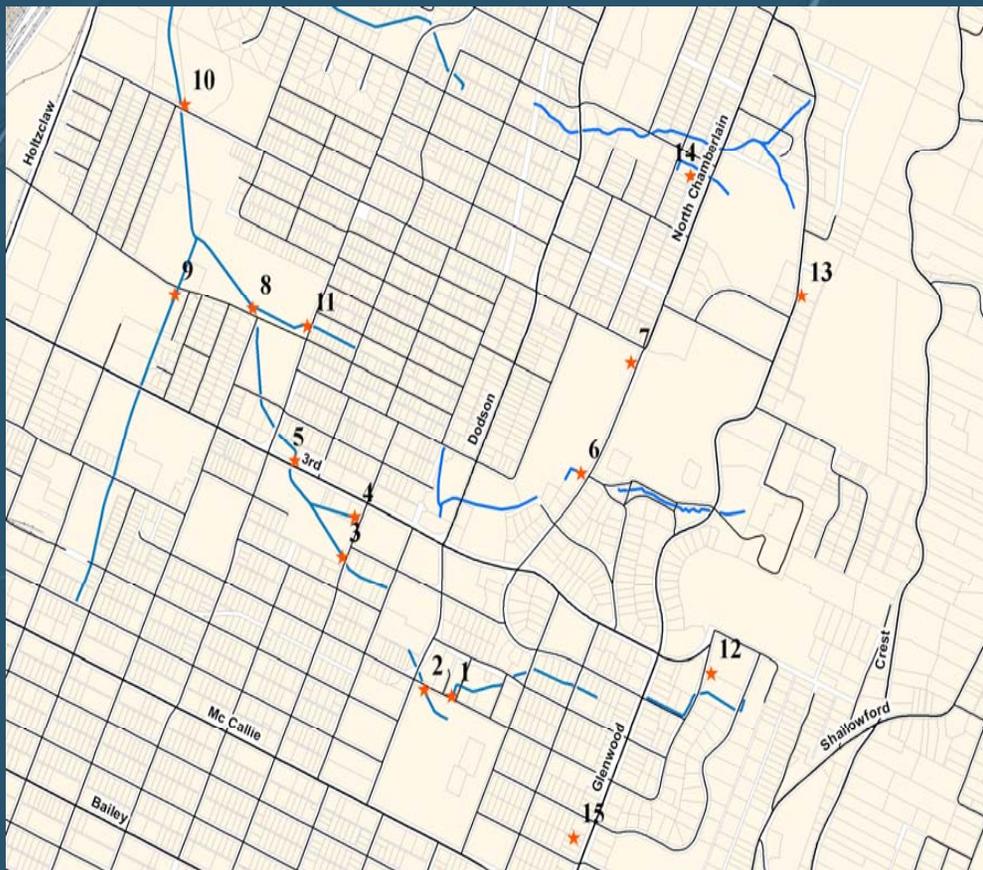
E. Coli (Col/100mL)

Preliminary results indicated a reduction in pathogen loading.

Station No.	May 2006	Feb. 2007
1	27,400	3,790
2	800	<100
3	1,400	<100
4	100	<100
5	1,190	<100
6	995	100
7	205	<100
8	1,840	520
9	3,660	8,550
10	4,280	100
11	3,880	<100
12	3,670	Dry
13	485	1,340
14	1,460	<100
15	550	100
